PROJECT: Brookview CA, Hillsborough, NJ **Drainage Improvements**

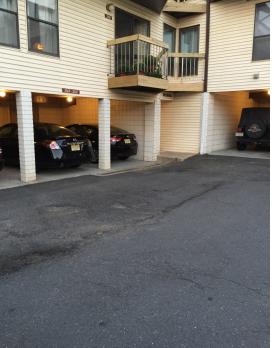
In the Fall of 2015, the Brookview Condominium Association in Hillsborough decided to correct their ongoing drainage problems at the entrances to a row of open garages at one of the multi-unit buildings on Revere Court. The problems were caused by storm water runoff from the adjacent courtyard and roof downspouts. The ponding would continuously collect on the interior concrete garage floor slabs. As a result, the garage Engage. Envision. Engineer. slabs and adjacent asphalt pavement were beginning to deteriorate. During freezing weather, the icing conditions would become hazardous to drivers and pedestrians. Kipcon observed the area and determined that a por-

> tion of the runoff drained toward existing trench drains that were not designed for this amount of runoff.

Are a of ponding which resulted in disturbed asphalt pavement.

- Kipcon prepared a topographic survey to obtain existing elevations of the paving and piping.
- Kipcon prepared specifications for the installation of a new trench drain along with a piping connection from the existing catch basins to the new trench drain, as well as repairs to existing holes in concrete garage floor slabs and areas of disturbed asphalt pavement.

- Kipcon specified a custom slot drain system to be installed that is less susceptible to freezing and debris blockage while remaining a less expensive remediation option than a traditional vehicular grade open concrete trench.
- This durable slot drainage system consists of a heavy duty vehicular grade aluminum drainage slot mounted to an opening along the top of the sloped subsurface piping.
